FIELD PERFORMANCE OF PRESERVED SHAKES AND SHINGLES

CONTRACT NUMBER: 301013612

**NATURAL RESOURCES CANADA, CANADIAN FOREST SERVICE
RESSOURCES NATURELLE CANADA, SERVICE CANADIEN DES FORÊTS**

May 2019

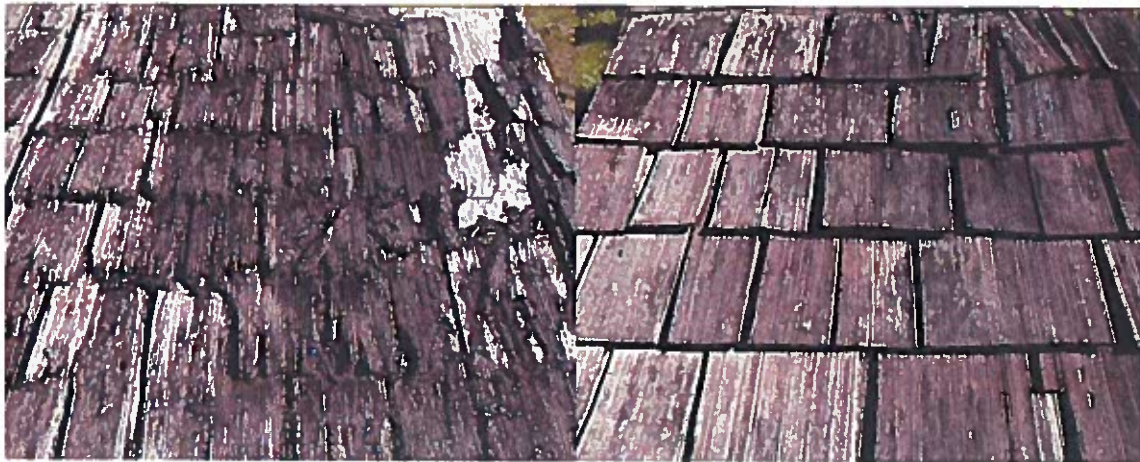
Figure 1. Untreated western redcedar shakes (left) and CCA-B treated western redcedar shakes (right) after 45 years of exposure in Maple Ridge, British Columbia.

After 45-years of exposure, all untreated western redcedar shakes had failed (Figure 1). Most had failed much earlier. In contrast, CCA-B treated western redcedar shakes were in relatively good condition, with an average decay rating of 8.9 (Table 6). Two of the 79 CCA-B treated shakes had failed due to decay. A moderate amount of erosion was observed. Splitting was more variable, with some shakes showing no splitting, and others fully split along the length of the shake.

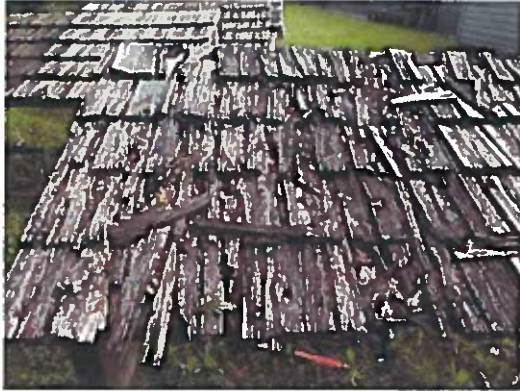
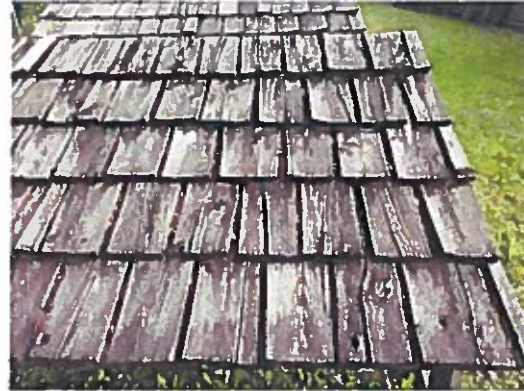
Figure 2. Untreated (left) and CCA-treated (right) spruce shakes after 24 years of exposure in Vancouver.

After 20-years of exposure, untreated pine and spruce shakes had advanced decay, or had failed (Figures 2-5). In contrast, CCA-treated pine and spruce shakes remained in excellent condition with no confirmed decay. The untreated western redcedar reference had low to moderate decay with an average rating of 8.0.

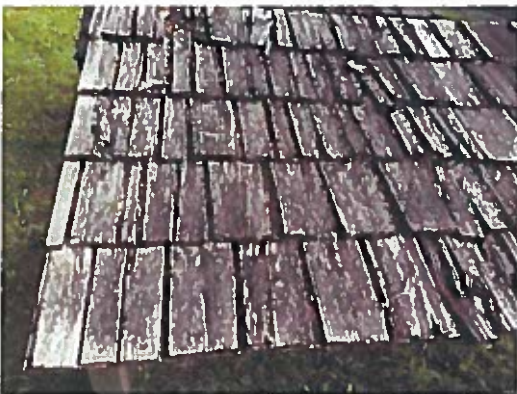
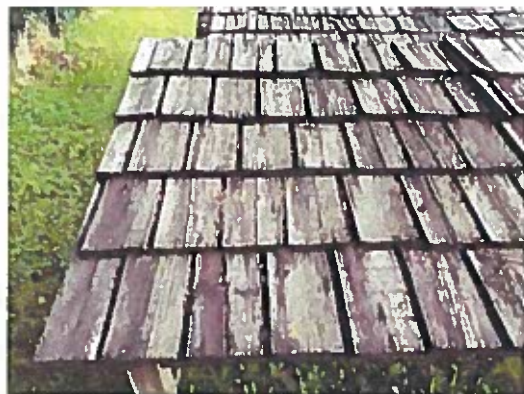
Figure 3. Untreated (left) and CCA-treated (right) pine shakes after 24 years of exposure in Vancouver.

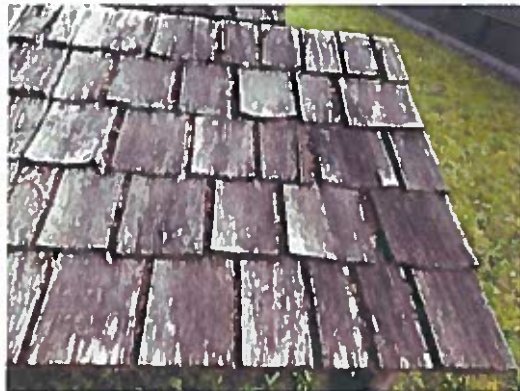
Figure 4. Untreated western redcedar shakes after 24 years of exposure in Vancouver.

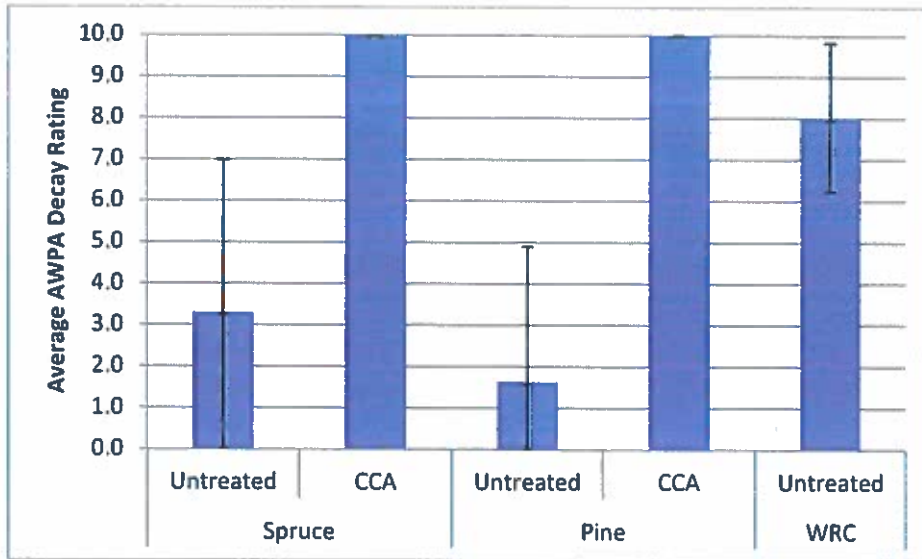
Figure 5. Average decay rating of shakes treated with selected preservatives after 20 years of exposure in Vancouver (error bars represent standard deviations).

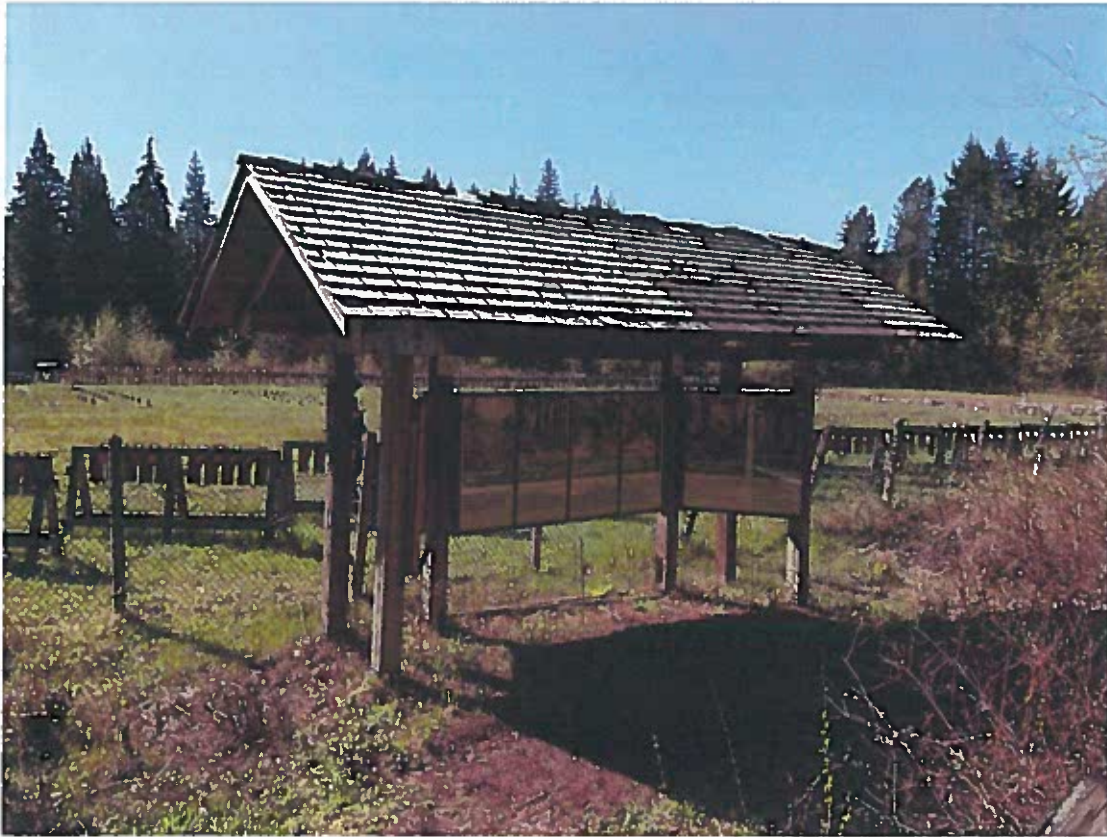
Figure 6. The sign shelter after 15 years of exposure in Maple Ridge.

After 15 years of exposure, the sign shelter remained serviceable (Figure 6). Early stages of decay were observed in south facing untreated western redcedar shingles, while advanced decay was observed in the north facing shingles (Figure 7). This is likely because the north facing shingles would be slower to dry, and therefore susceptible to decay for longer periods of time. This rate of decay is similar to previous evaluations of untreated western redcedar shakes (Morris *et al.* 2013). ACQ-D and CA-B treated shingles were mostly sound after 15 years of exposure. Early stages of decay were observed in shingles treated with oxine copper or propiconazole.

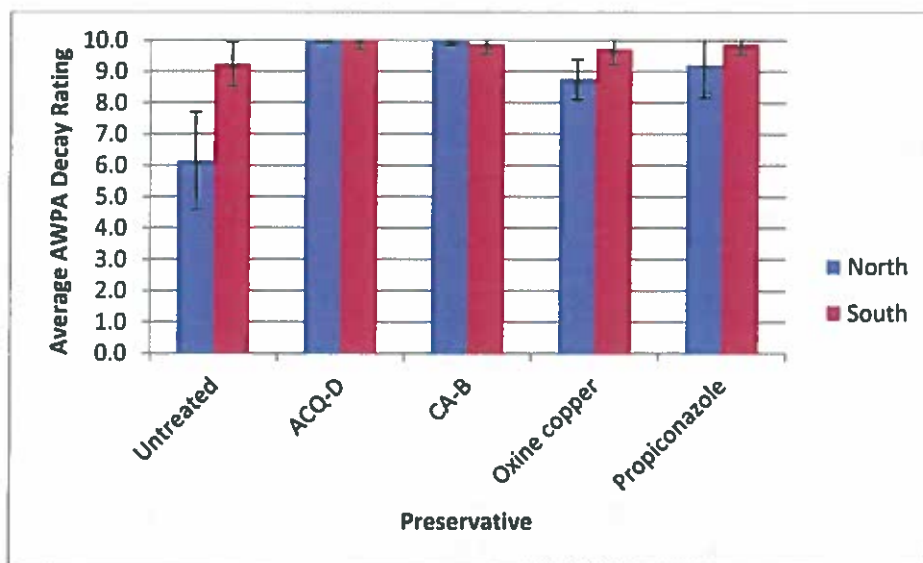
Figure 7. Average decay rating of western redcedar shingles treated with selected preservatives after 15 years of exposure in Maple Ridge.

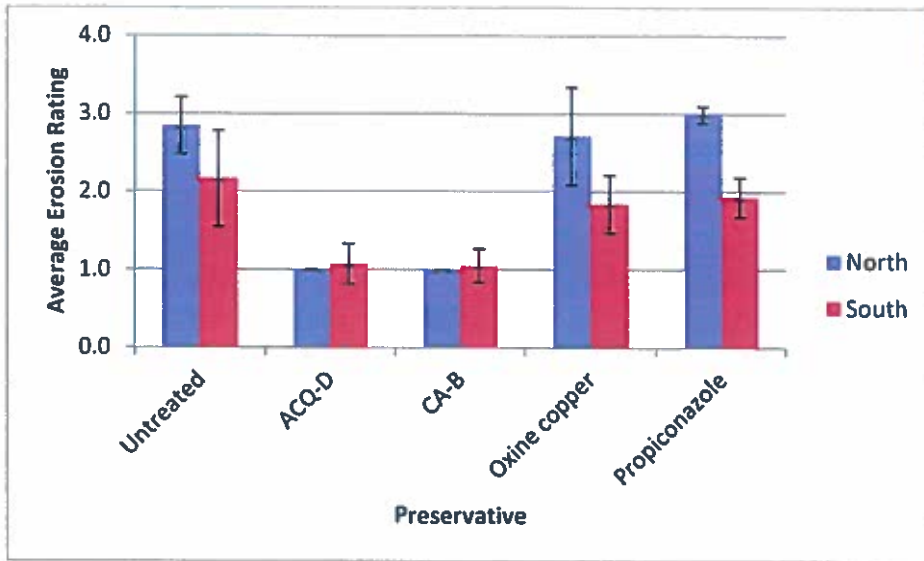
Figure 8. Average erosion rating of western redcedar shingles treated with selected preservatives after 15 years of exposure in Maple Ridge.

Erosion was more prominent on north facing samples that were untreated, or treated with oxine copper, or propiconazole (Figure 8). ACQ-D and CA-B treatments were associated with low levels of erosion on both north and south facing surfaces. This is further evidence of the photo-protective effects of copper when present in sufficient quantities (Liu *et al.* 1994).

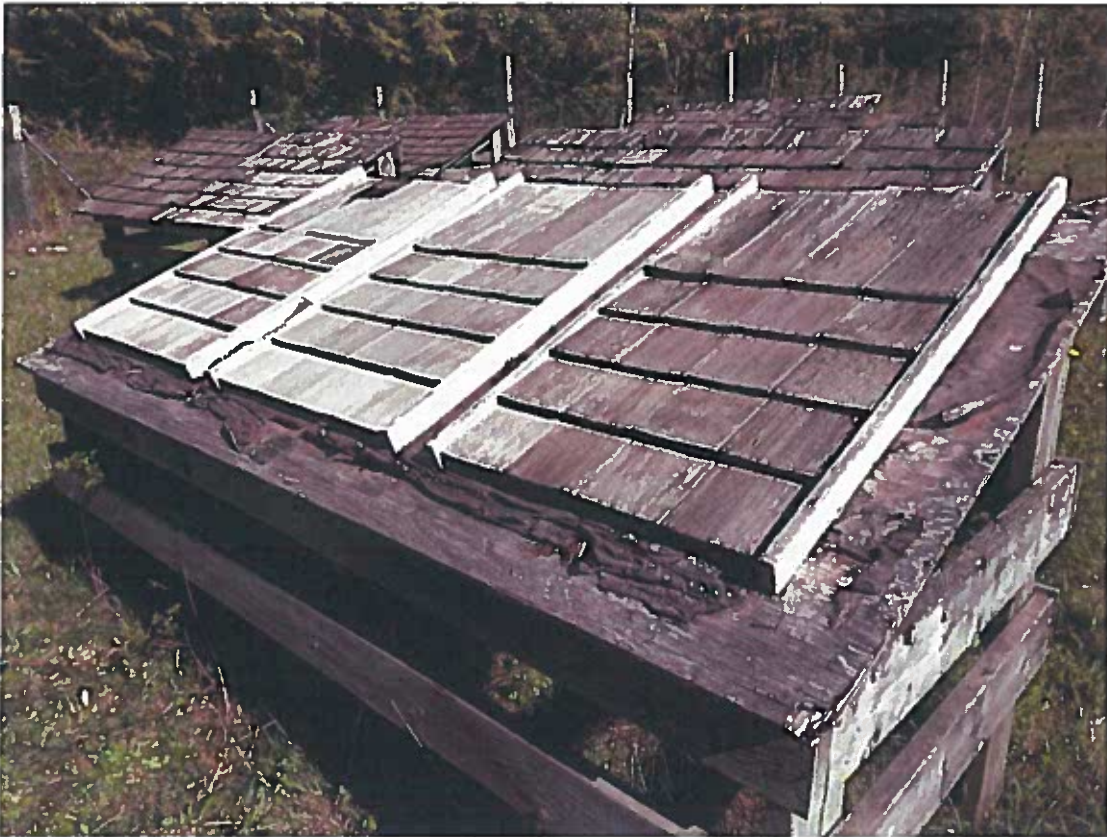
Figure 10. Western redcedar shingles dip treated with DDACarbonate and alkylamine oxide (left), pressure treated with DDACarbonate and alkylamine oxide (centre), and untreated (right).

There was no evidence of decay in any of the untreated or treated western redcedar shingles in this study (Figure 10). Average erosion ratings were the same in each group, though it was observed that the DDACarbonate and alkylamine oxide treated shingles had retained their brighter colour (Stirling 2014). Only one untreated specimen was rated 1 for splitting; all other specimens were rated 0 (Table 7). The lack of activity after approximately five years of exposure is consistent with results from previous experiments.
